Failure analysis of metallic structures and components: part II- a case study

Ashraf Ragab Ali Mohamed

Structural Eng. Dept, faculty of Eng. Alexandria University, Alexandria, Egypt

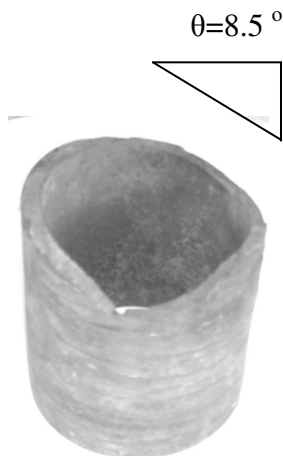
Fig. 2. The inclination angle of the fractured surface.

The failure surface has an inclination angle of approximately 8 to 9° as shown in fig. 2 indicating that the main cause of failure is associated with axial stresses in the long direction of the cylinder.

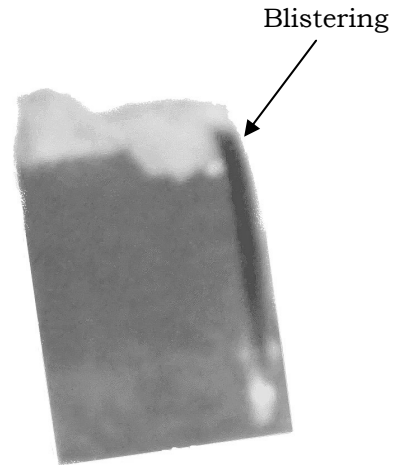
Fig. 4. Hydrogen blistering as observed in testing.

7. Blistering phenomenon associated with hydrogen embrittlement have been observed for the failed pipe and during experimental testing supporting the theory of failure proposed.

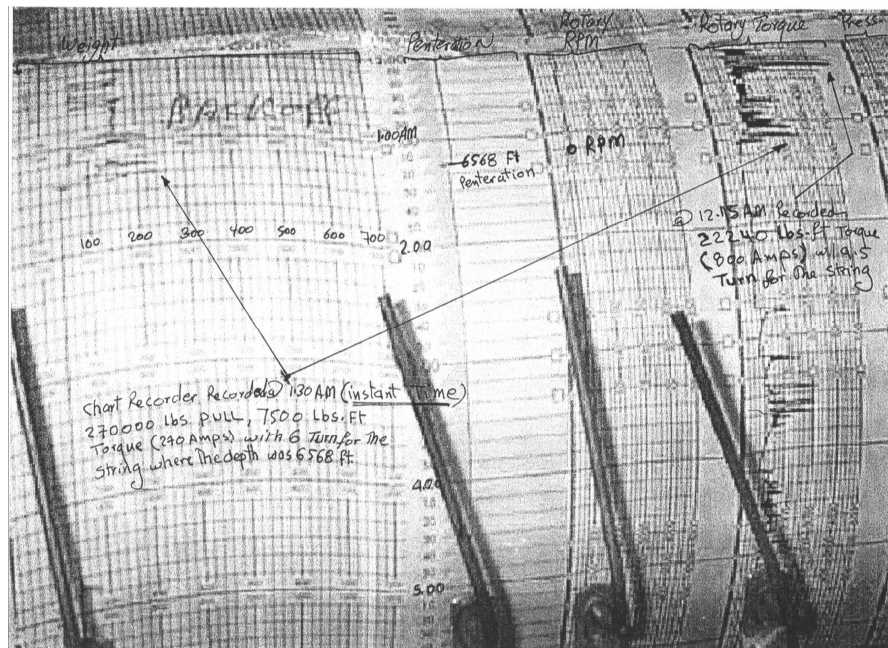
Simplified stress calculations for the stress state in the drilling pipe at the moment of failure were conducted. As reported in the records, the tensile force and the applied torque acting on the pipe were: $T=1.2$ MN and $M_T= 10170$ N-m, respectively, as shown in fig. 5. The measured internal diameter of the pipe was 110 mm. The average thickness of the pipe wall was 8.66 mm. Under this loading condition, the axial tensile stress $\sigma_x=372$ MPa, and the shear stress $\tau_{xy}=56.67$ MPa. Thus, the principal stresses were found to be; $\sigma_1 = 380$ MPa and $\sigma_2 = -8.4$ MPa, where the angle of inclination for the principal axis was 8.477°

Fig. 5. Records of tension and torsion at failure.

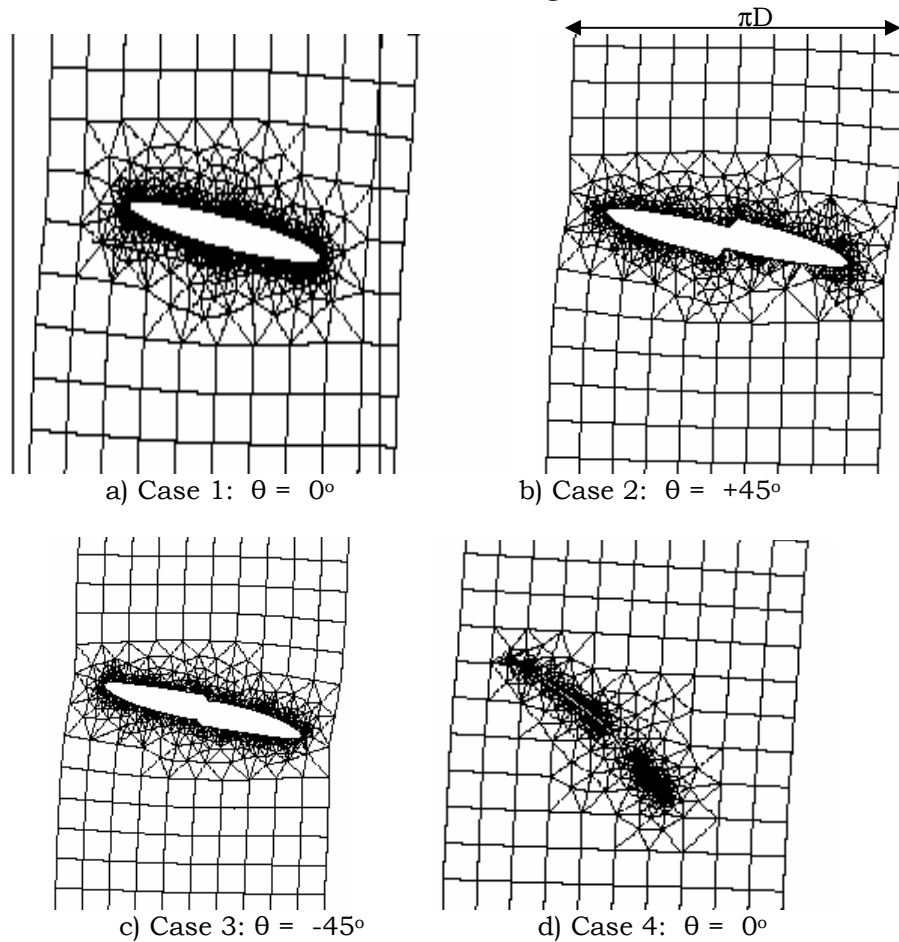
length orientation, numerical simulations show the same orientation of the final crack propagation (around 8 to 9°). This finding is very important as it coincides with the plane of principal stresses in the preliminary stress analysis, and the observed plane of failure as well.

Fig. 6. Numerical simulation of crack propagation.

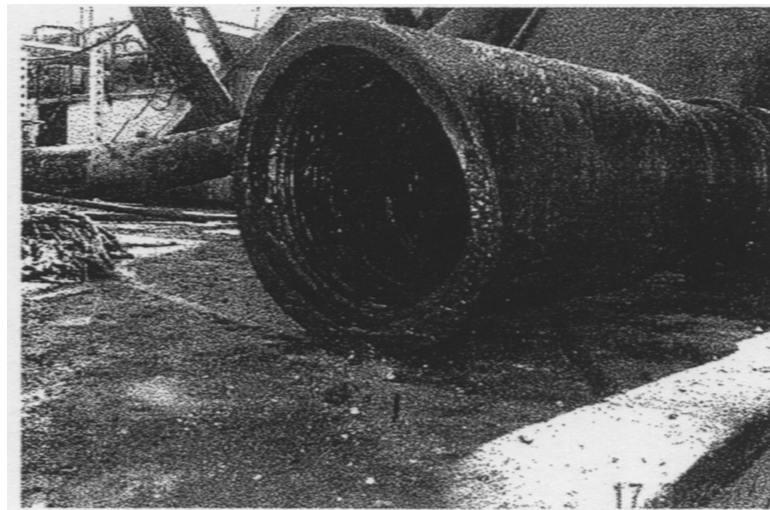
existence of any defects in the pipe wall or a hydrogen blister had led to the initiation of a certain crack with any random orientation. Due to the high stress intensity factor imposed by the high tensile stresses, in addition to the considerable reduction in fracture toughness owing to hydrogen embrittlement, the stress intensity factor at the crack tip reached a critical value and the crack started to propagate. The propagation of the crack, as observed from the fractured surface, was inclined 8 to 9° to the horizontal, meaning that the main cause of stress intensity increase was the tensile force in the pipe direction. The same angle of inclination is also obtained during preliminary stress calculations, and numerical crack propagation, which supports the hypothesis that the axial tensile load played the dominant role in the failure of the pipe. However, as crack continued to propagate, the ligament of the pipe (i.e. the remaining uncracked part of the pipe) was not aligned with the applied force at the other end of the pipe. This led to very large eccentricity between the applied load and the resisting ligament. High bending stresses at both ends developed and with more crack propagation, both the eccentricity and the bending moment increased until the complete failure of the pipe. This explains the bending of the pipe at the other end of it far from the fractured surface as shown in fig. 7. This concludes the failure mechanism and the

Fig. 7. Photo of the other end of the pipe after failure.
