# SIMPLY SUPPORTED REINFORCED CONCRETE SQUARE SLABS SUBJECTED TO CENTRAL LINE - LOAD EXPERIMENTAL STUDY

M.A. Helmy , I.E. Korish, R.R.F. Zaghoul and M.H. Marzouk\*

Structural Engineering Department,  
Faculty of Engineering, Alexandria University  
Alexandria, Egypt

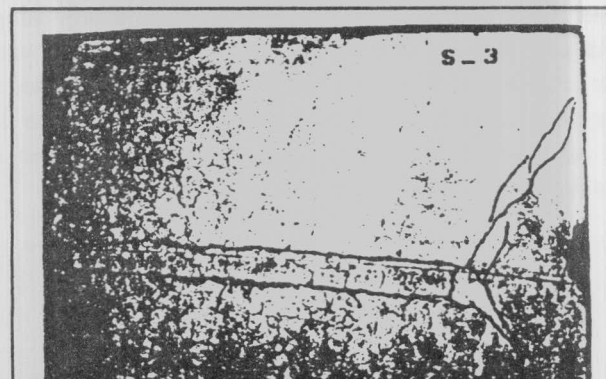
Figure 5. Tension side of (S-3) after failure.

Generally, the modes of failure of the slabs of this group were similar, see Figures (3) through (6). This mode can be idealized to follow the yielding pattern as shown in Figure (7).
